**EMERGENCY STRUCTURAL ASSESSMENT
OF
EARTHQUAKE DAMAGE TO
NORTH KAWAIHAE SMALL BOAT HARBOR
LOCATED AT
KAWAIHAE, HAWAII**

**PREPARED FOR
THE STATE OF HAWAII
DEPARTMENT OF LAND AND NATURAL RESOURCES
DIVISION OF BOATING AND OCEAN RECREATION**

**PREPARED BY
ARNOLD T. OKUBO & ASSOCIATES, INC.
94-529 UKEE STREET, SUITE 107
WAIPAHU, HAWAII 96797**

NOVEMBER 2006

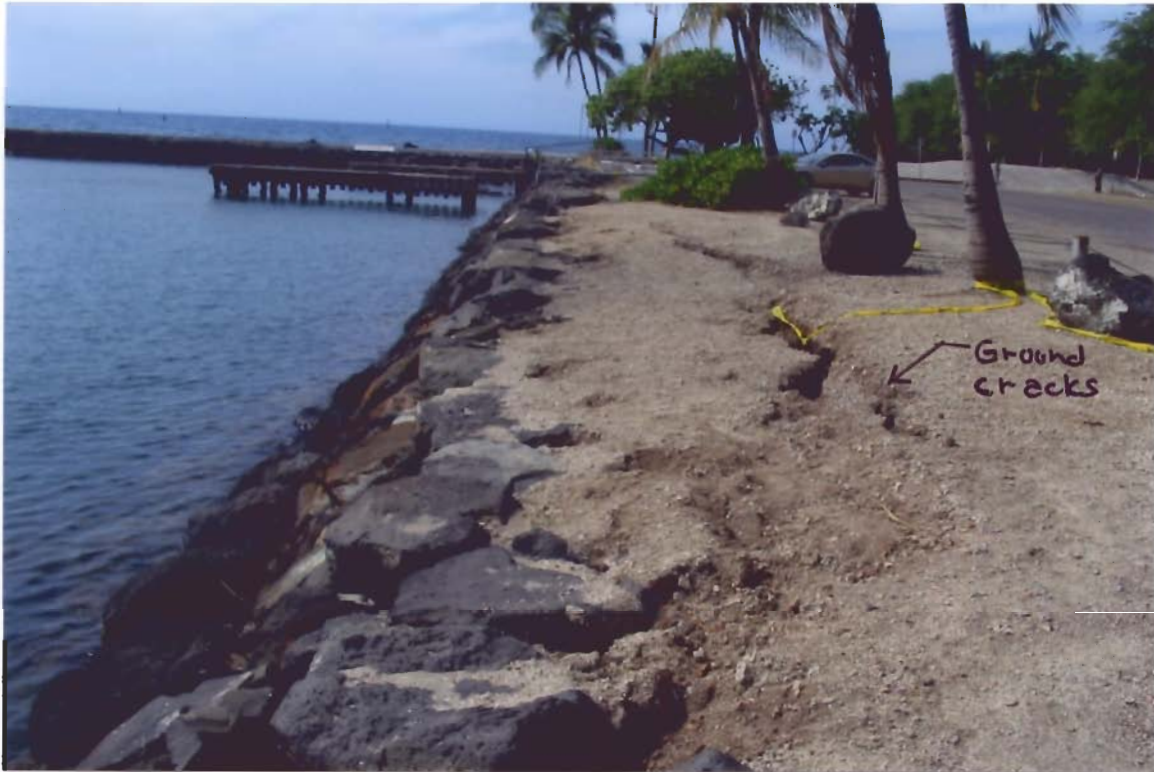
3

North Revetment Wall - Ground movement and settlement

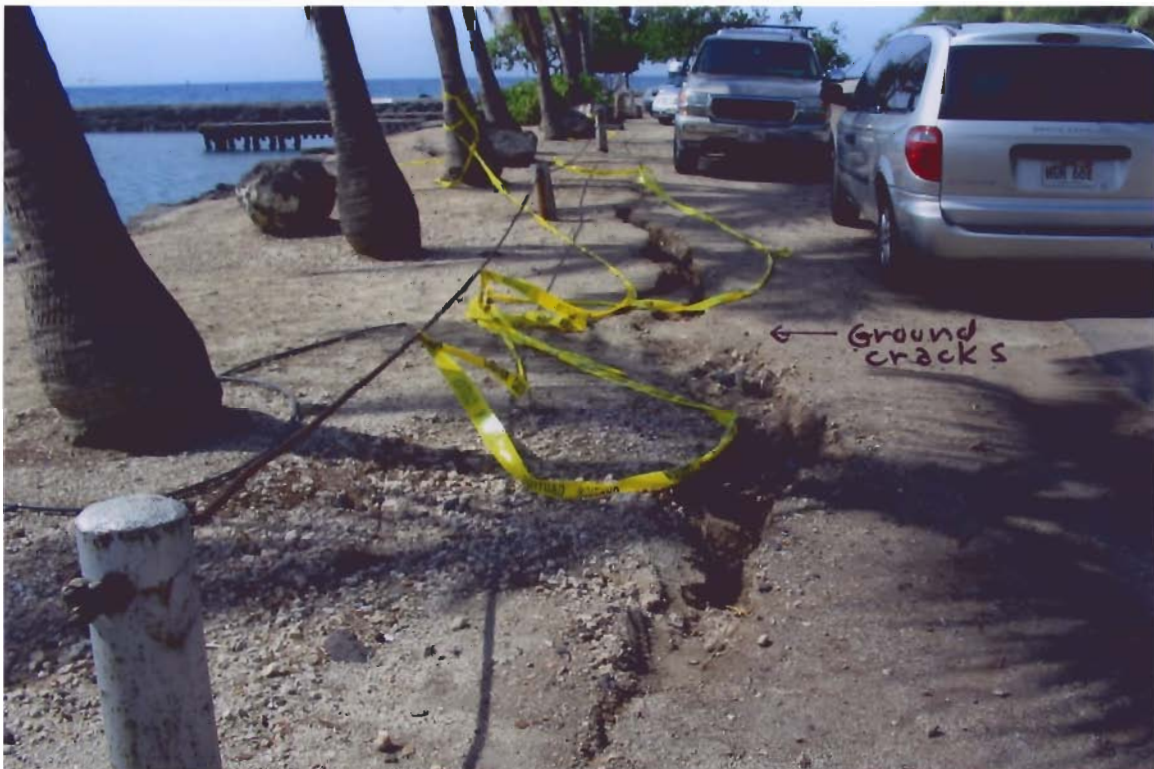
4

Area Behind North Revetment Wall - Ground movement and settlement

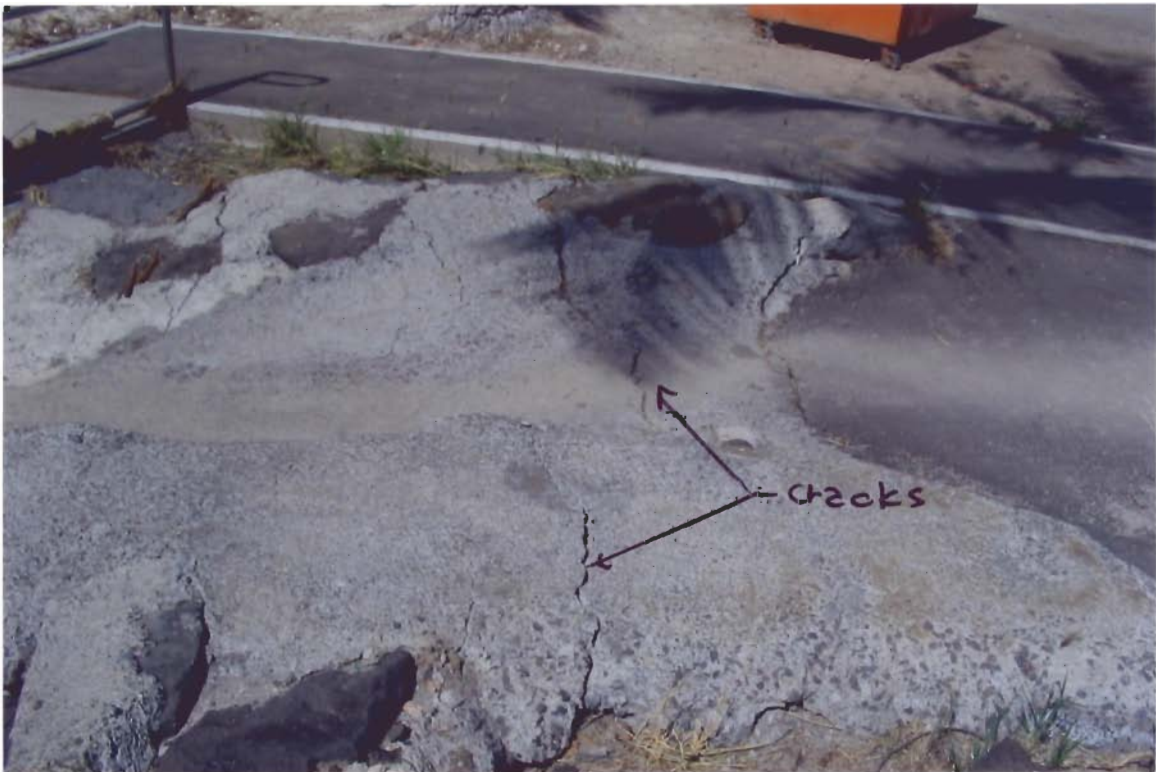
6

The rock mound/revetment seawall has shifted outward along the length and parallel to the marginal wharf. Visible cracks, separations and settlements, can be seen on the ground and revetment seawall surfaces.

Marginal Wharf - Cracks at
rock revetment seawall

The rock revetment seawall along the marginal wharf has significant displacement and movement caused by the earthquake. The rock revetment seawall should be reconstructed to protect the landside from erosion and sliding.

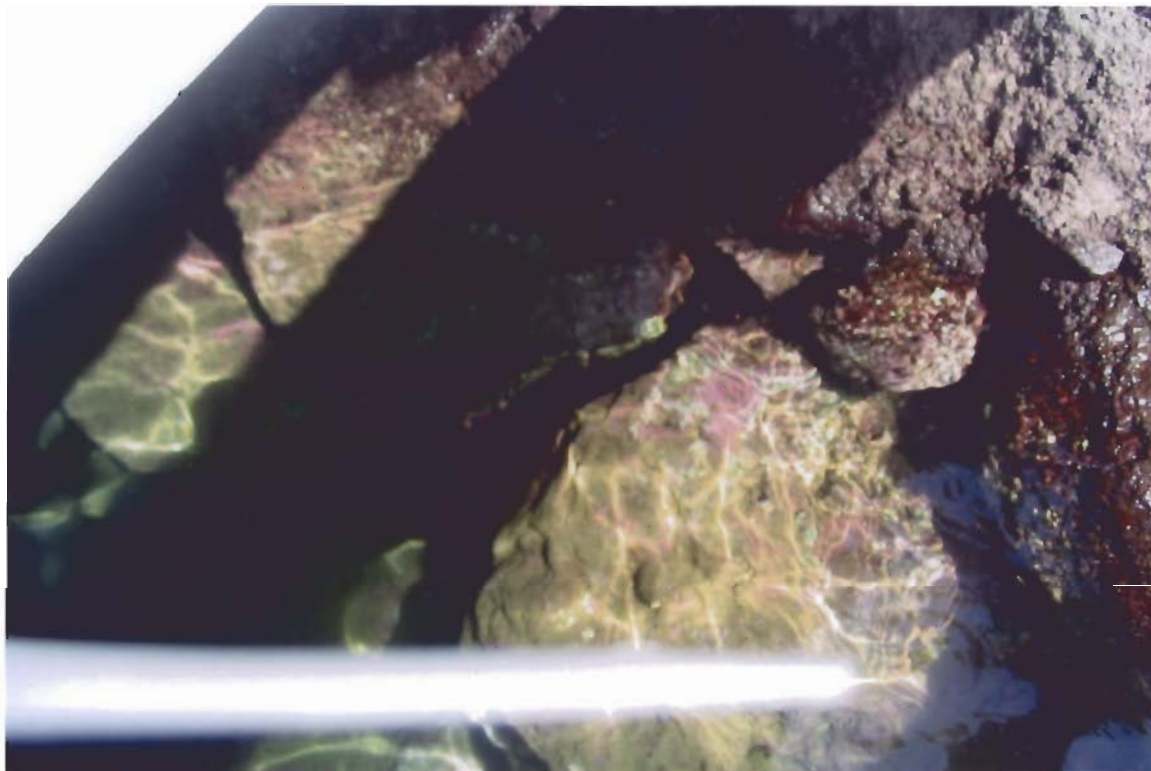
15 Rock revetment seawall separated at toe of wall

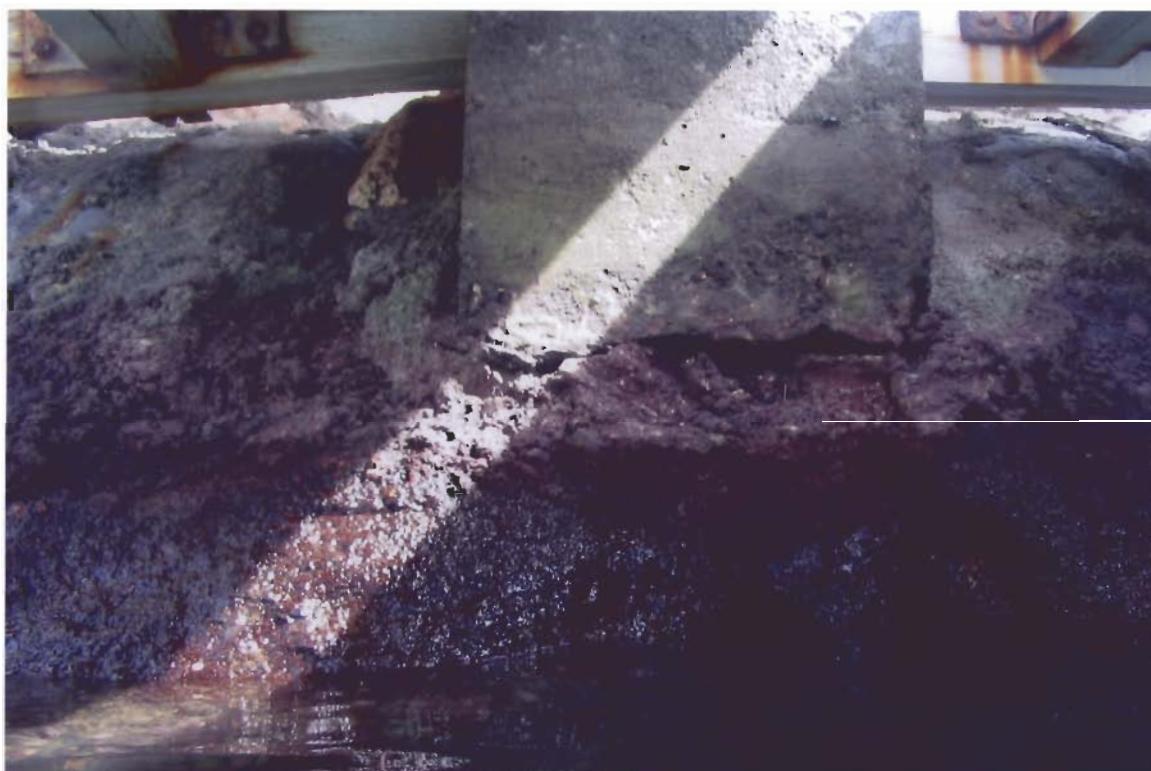
There were some movement of the wooden deck concrete support caps at the landside adjacent to the rock mound/revetment seawall. The wooden deck structure was already not in use due to a previous wave damage. The writer had previously inspected the wooden marginal wharf deck on March 2, 2006 and the wooden wharf deck structural condition in the writer's opinion has not change due to the earthquake.

16 Concrete support pedestal for deck separated from rock revetment seawall

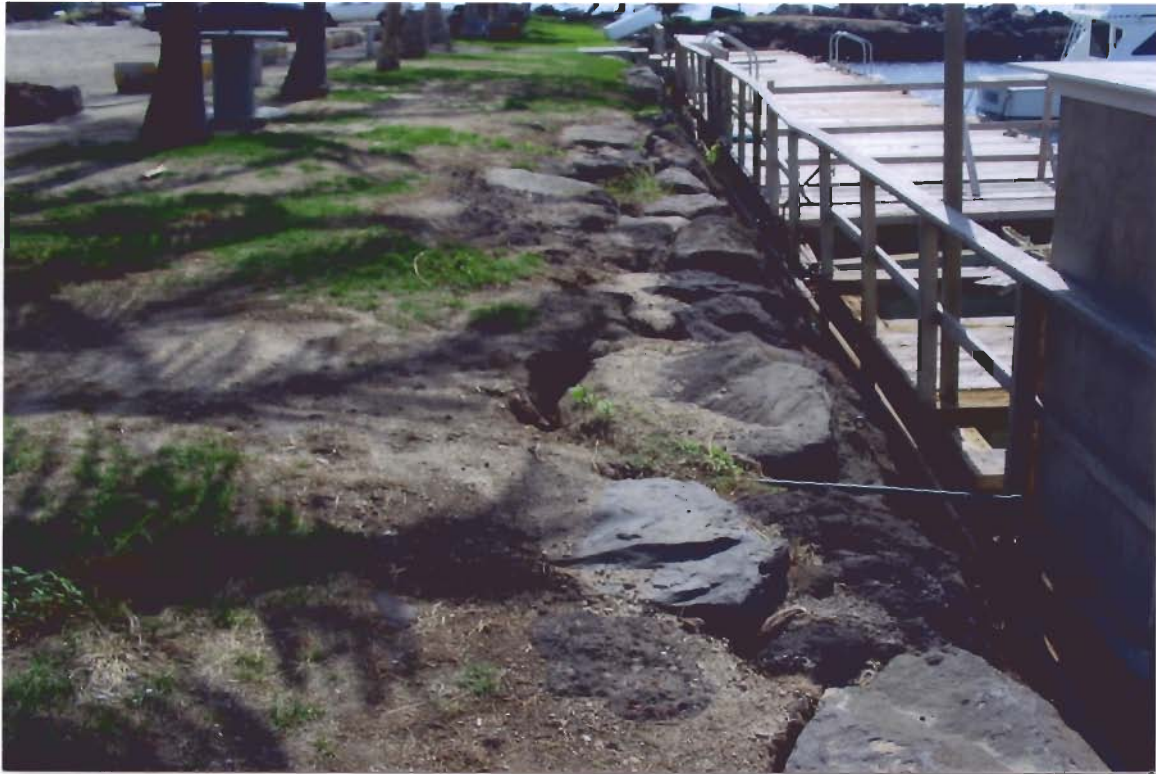
17 Movement and separation of rock revetment seawall along East Side of Marginal Wharf - (Looking South)

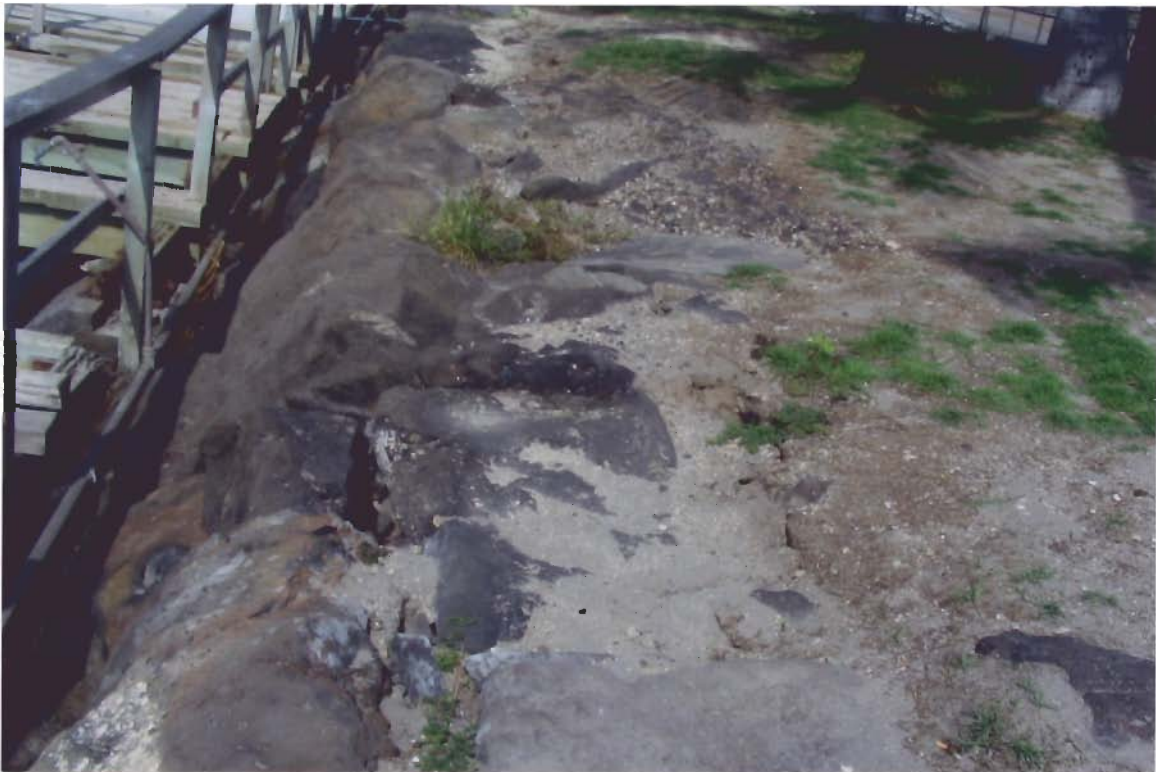
18 Movement and separation of rock revetment seawall along East Side of Marginal Wharf - (Looking North)

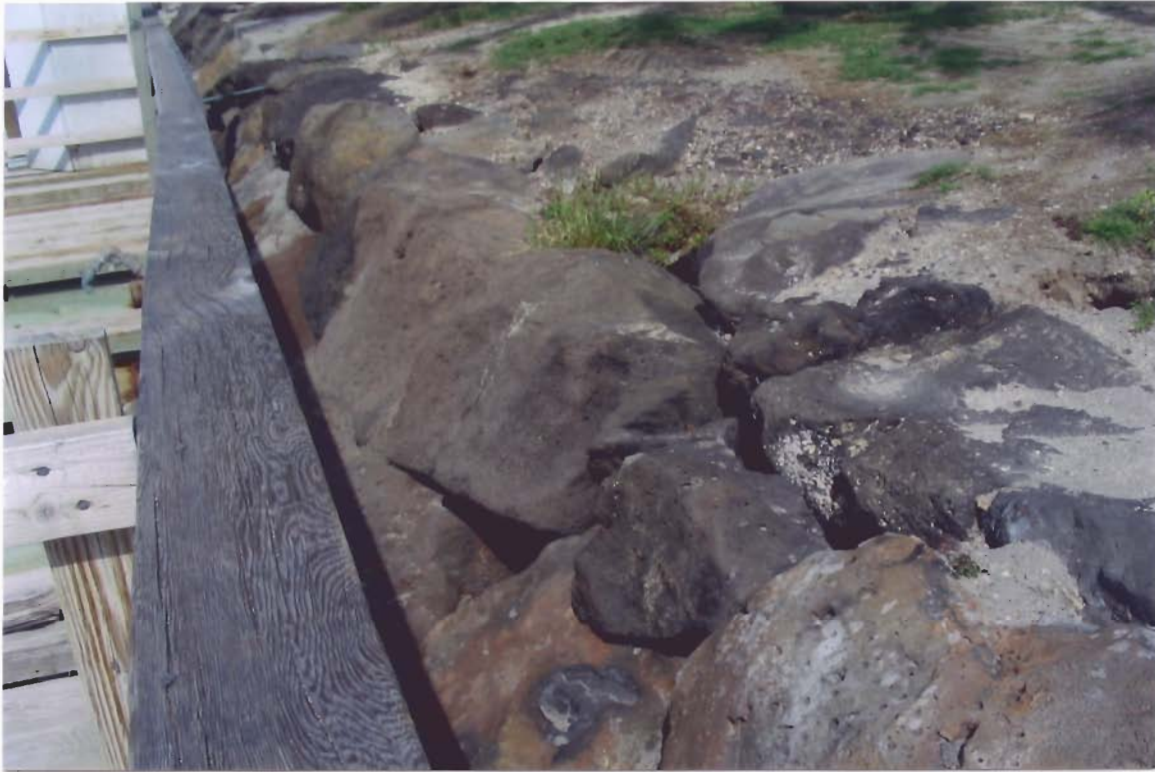
19

Movement and separation of rock revetment seawall
along East Side of Marginal Wharf - (Looking North)

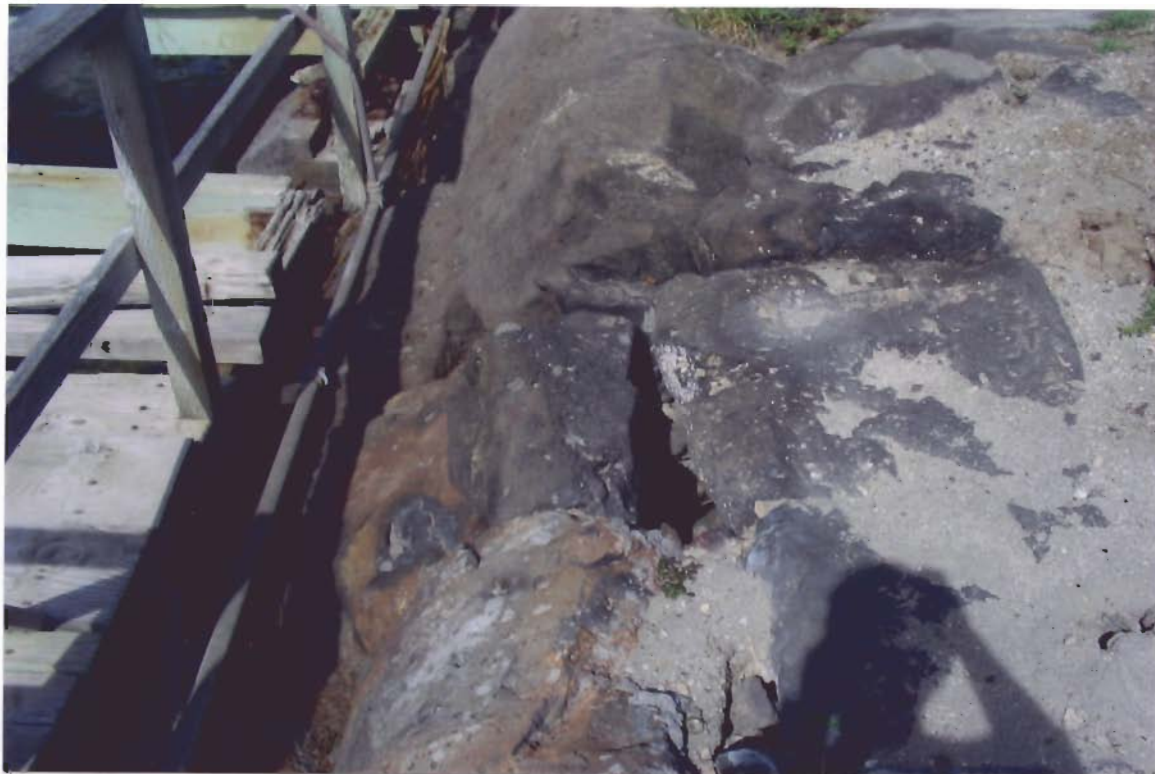
20

Movement and separation of rock revetment seawall
along East Side of Marginal Wharf - (Looking North)

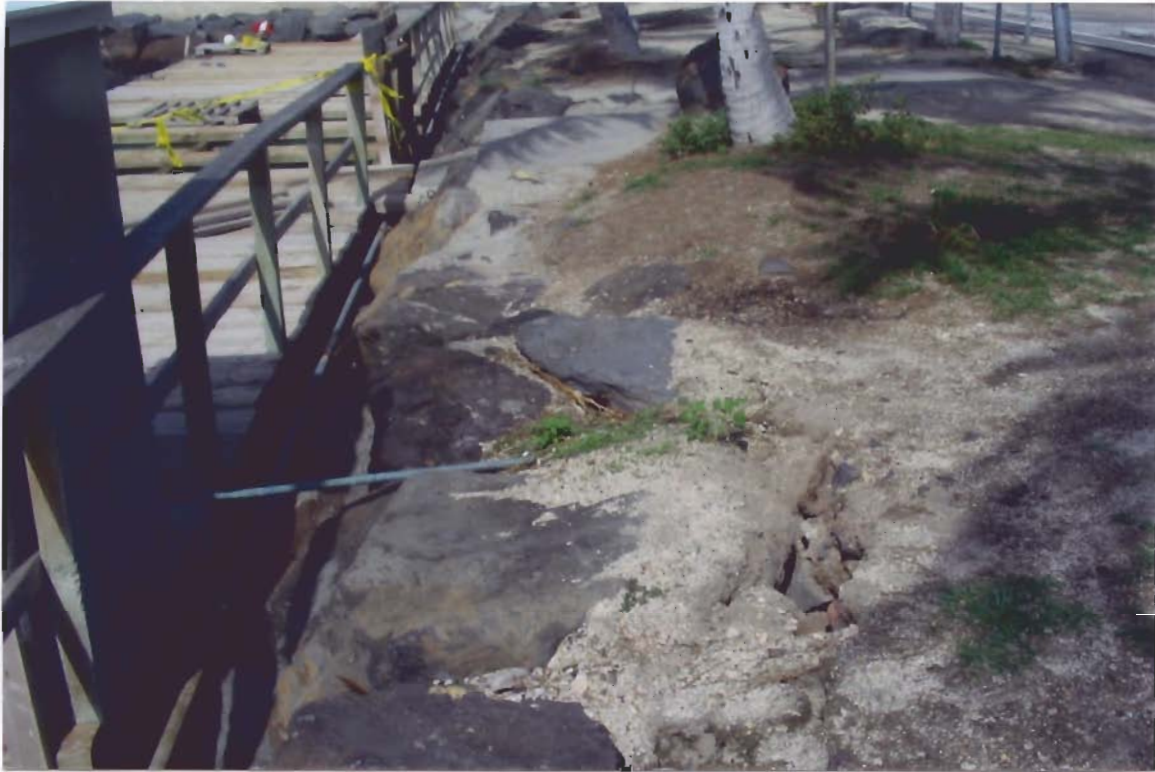
21 Movement and separation of rock revetment seawall along East Side of Marginal Wharf - (Looking North)

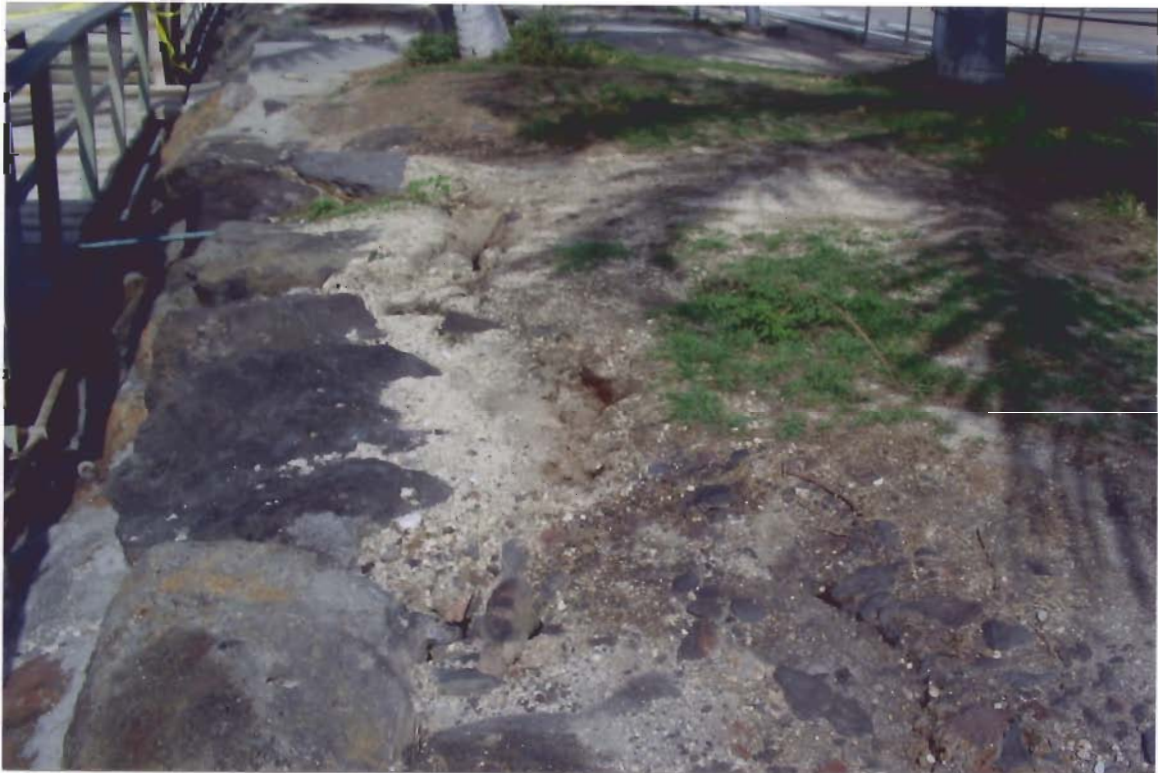
22 Movement and separation of rock revetment seawall along East Side of Marginal Wharf - (Looking North)

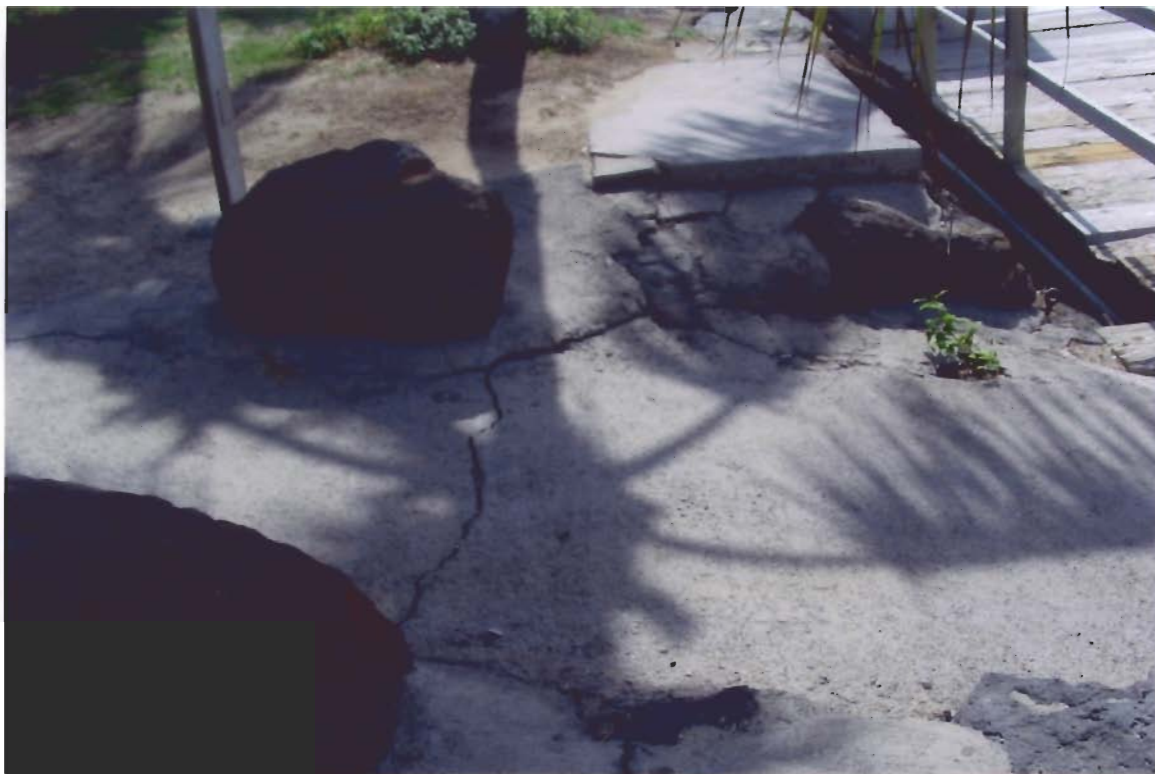
23

Crack and movement of rock revetment
seawall and crack slab

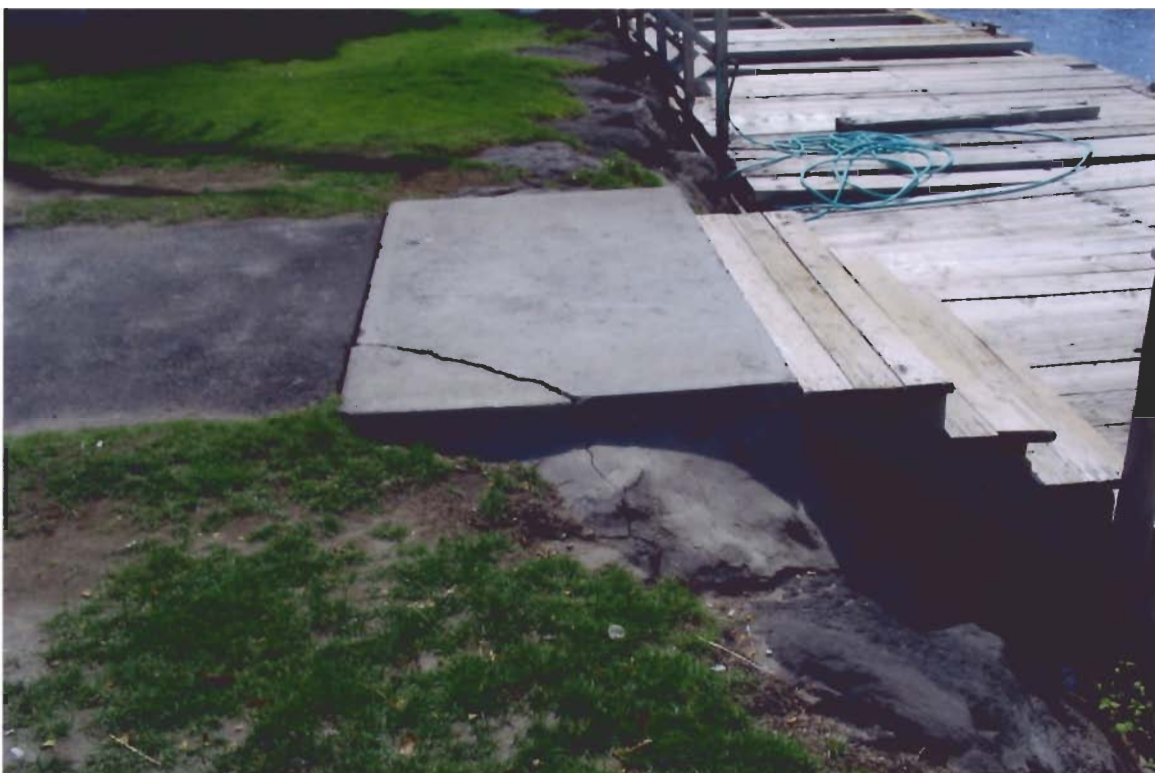
24

Crack landing slab at stairway
to Marginal Wharf

The concrete stairway landings are cracked and should be reconstructed.

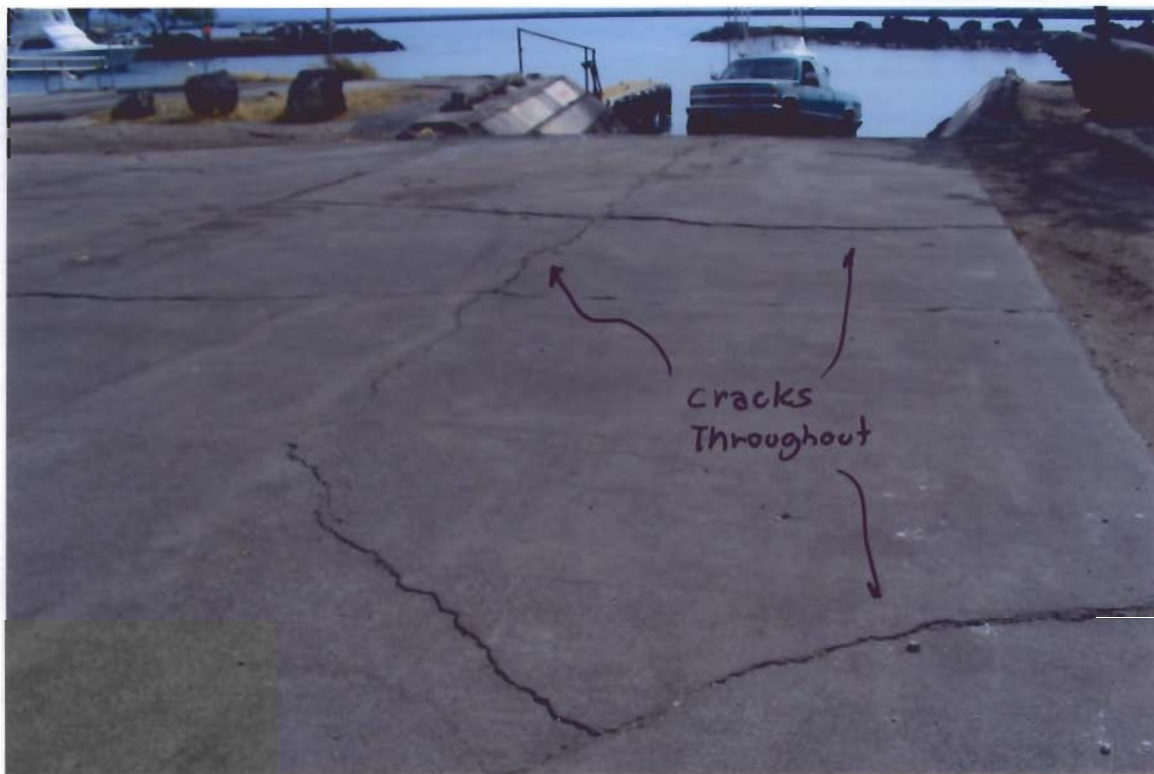
25

North Side - Cracks at Boat Launching Ramp
approach ramp concrete slab

The boat launching ramp has significant cracks and should be reconstructed. The approach slab and pavement also has large cracks throughout and should be reconstructed.

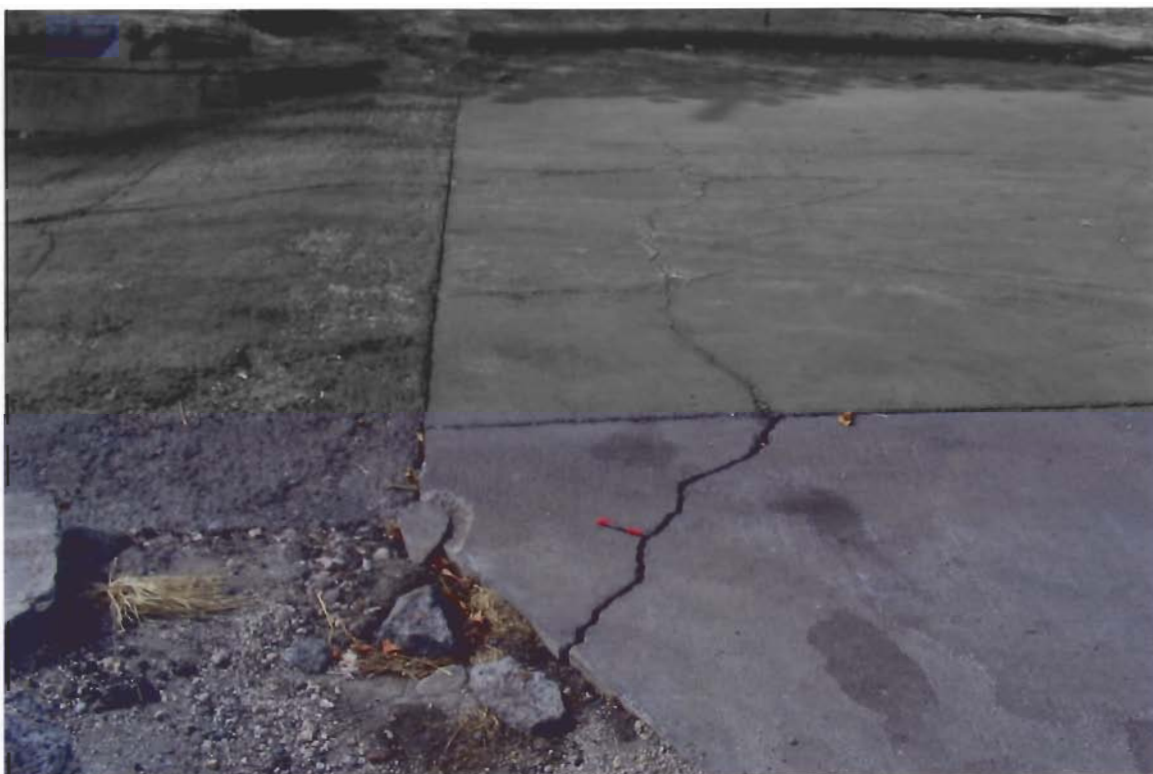
26

Cracks at Boat Launching Ramp
approach concrete slab

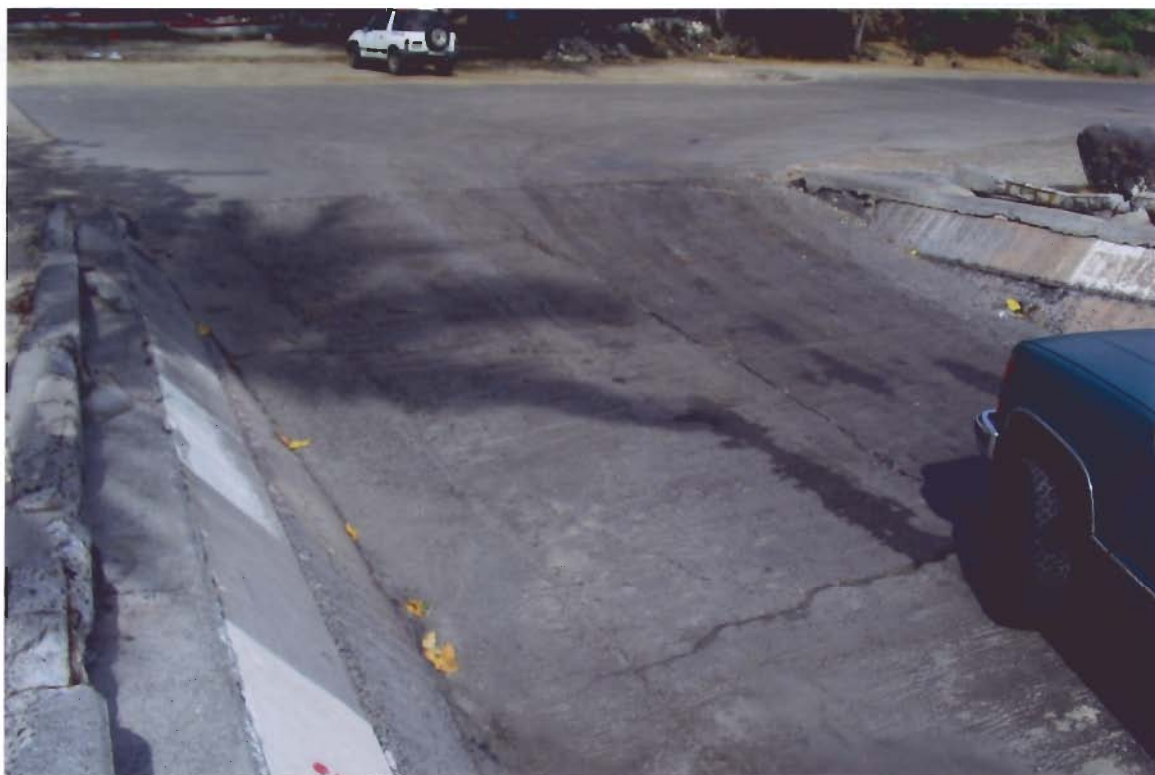
27 Cracks on Boat Ramp Concrete Slab

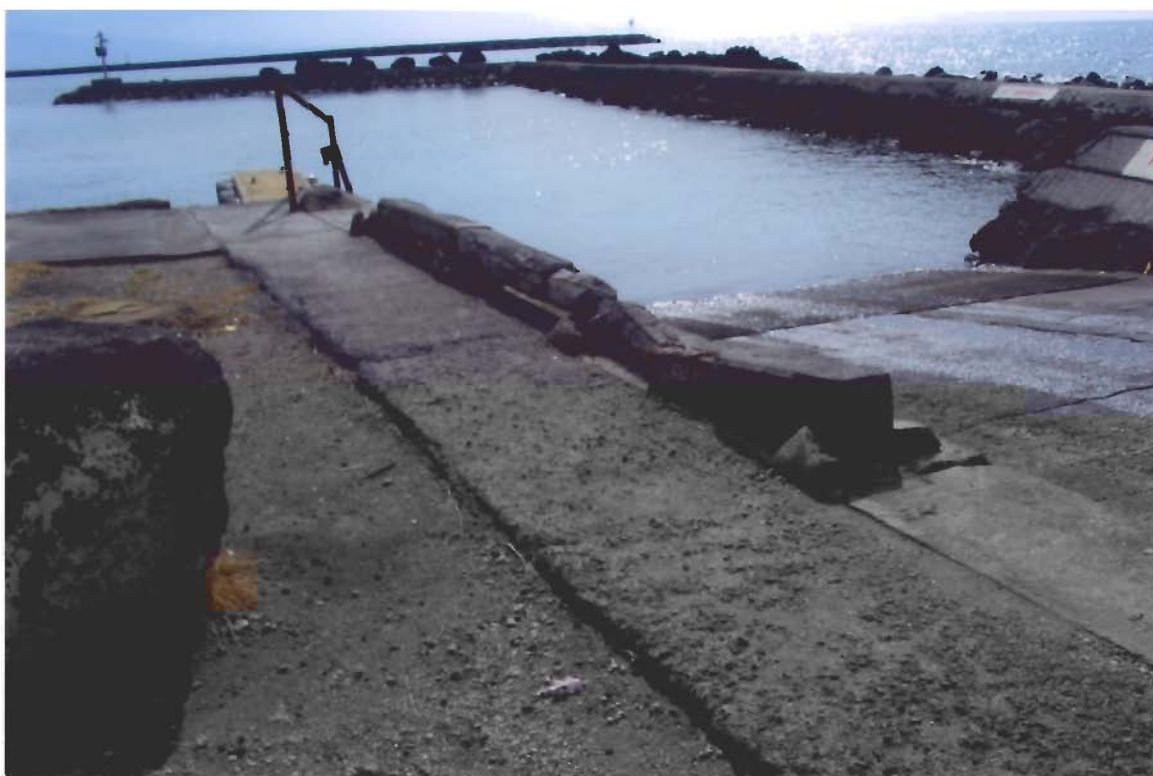
28 Failed Concrete Pile Curb at Boat Ramp

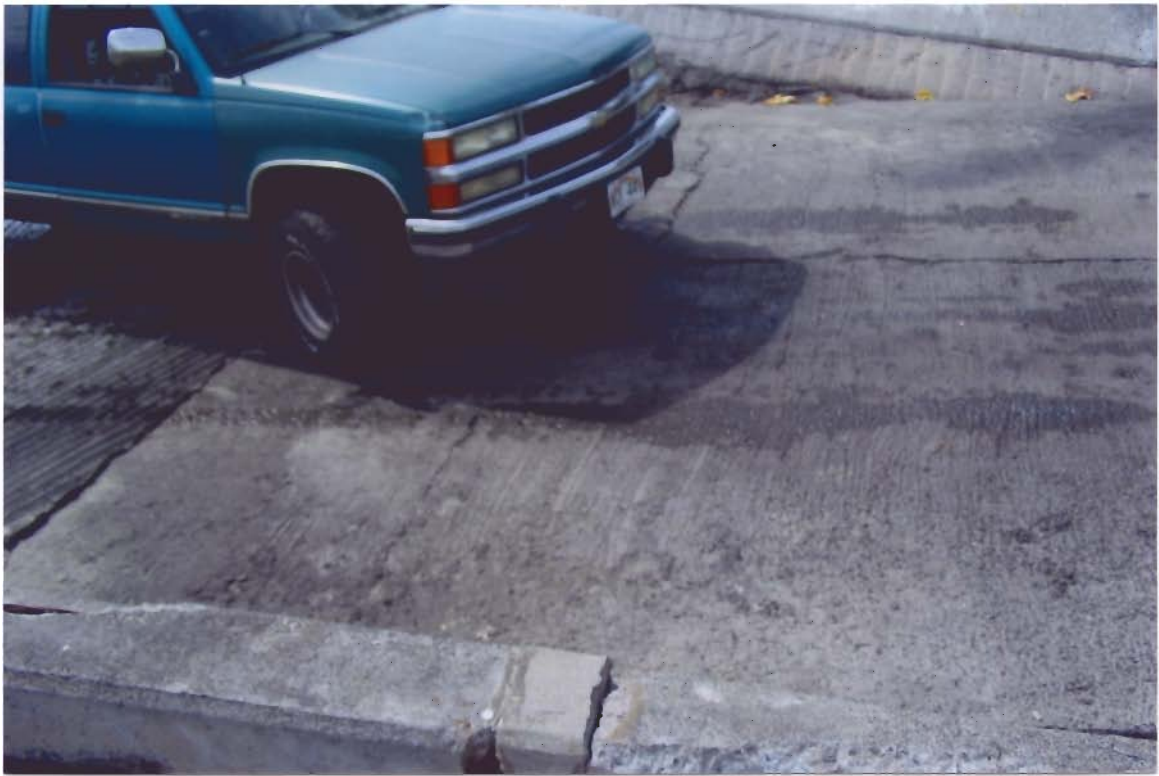
29

Cracks at Boat Ramp Slab

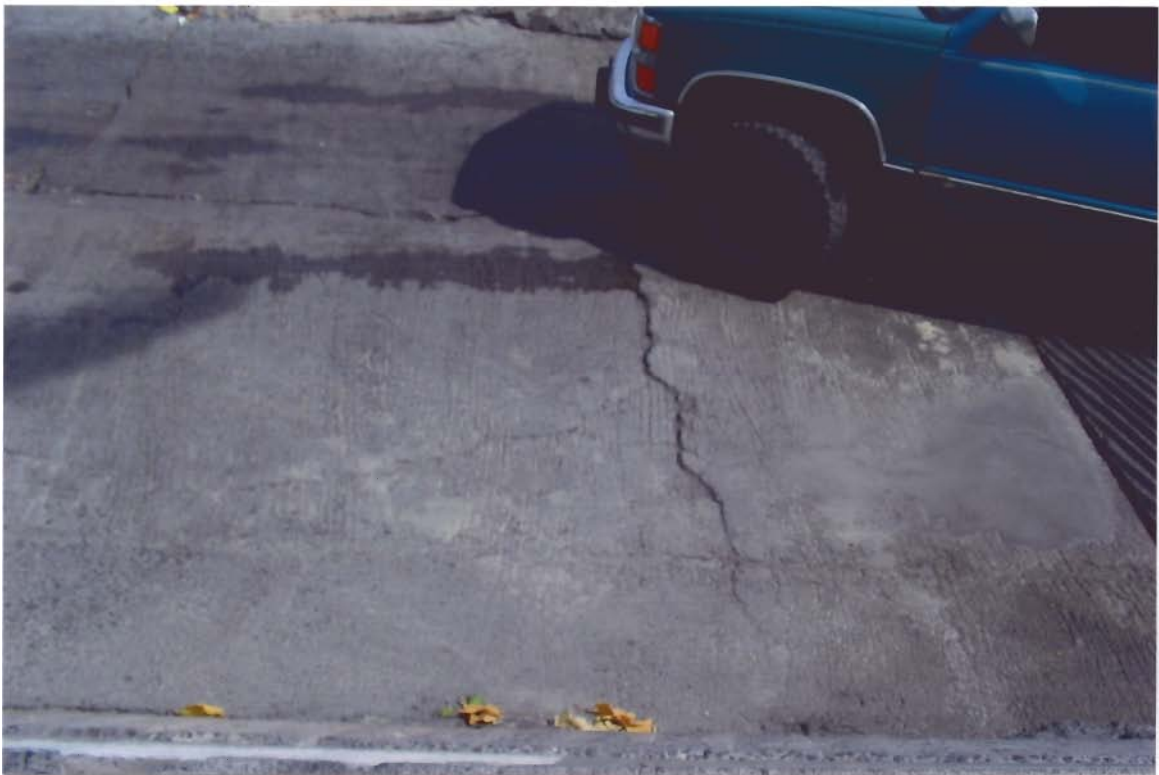
30

Cracks at Boat Ramp Slab

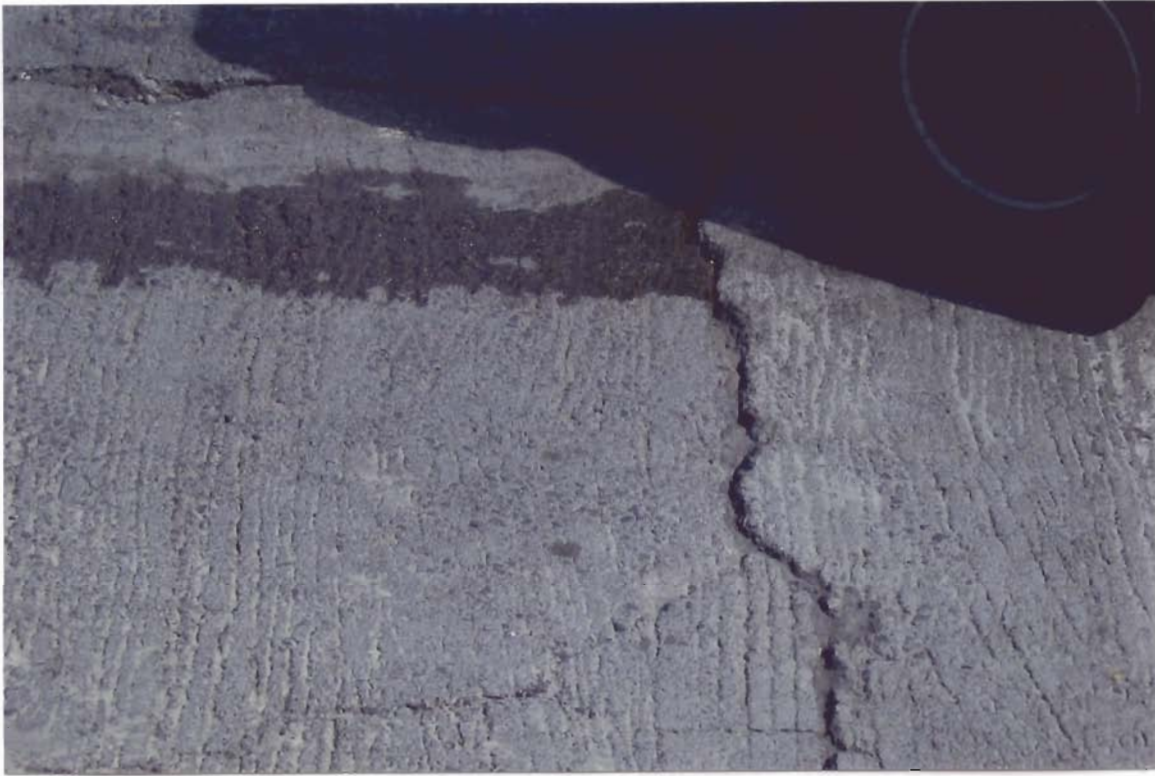
31 Close-up view of cracks at Boat Ramp Slab

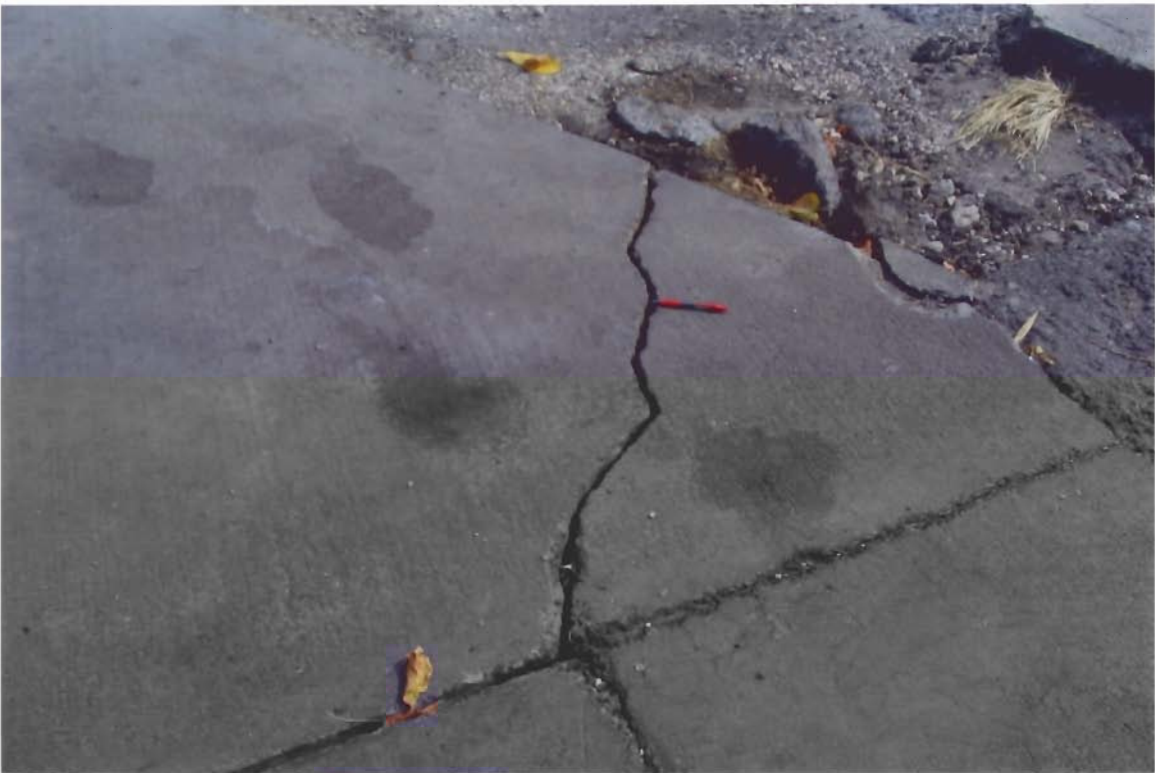
32 Cracks at Boat Ramp Slab

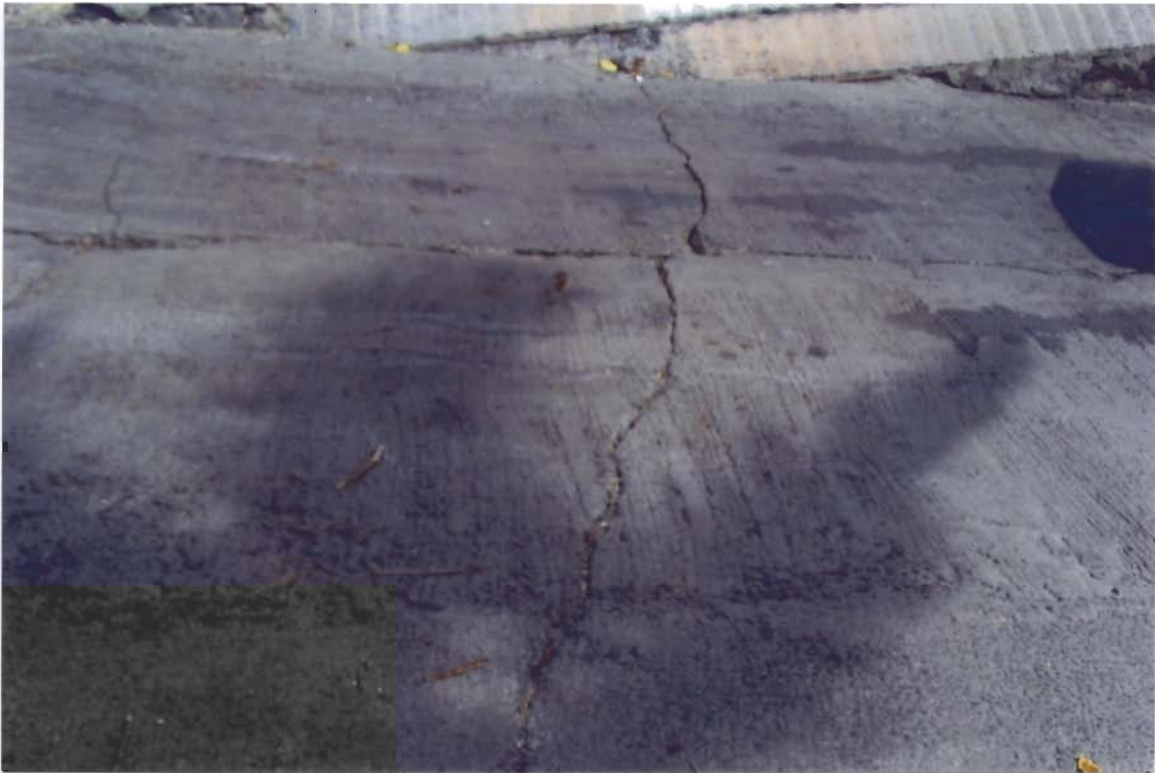
33

Cracks at Boat Ramp Slab

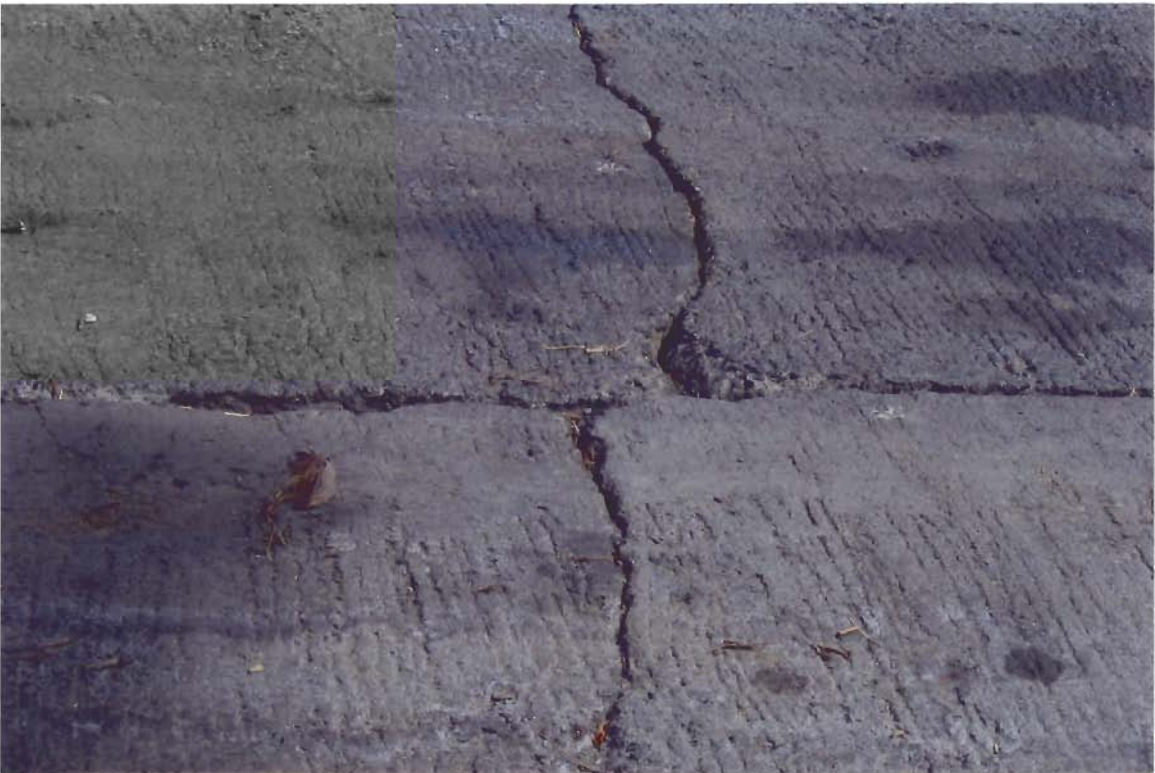
34

Cracks at Boat Ramp Slab

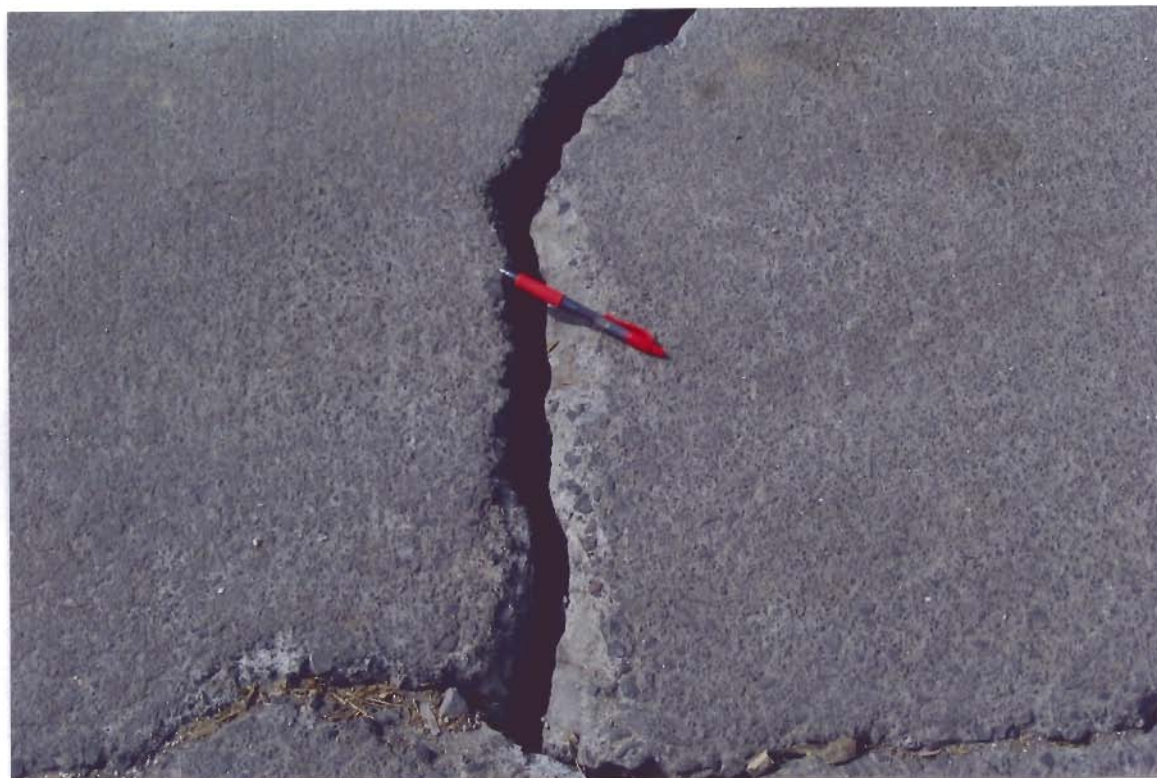
35

Cracks at Boat
Ramp Slab

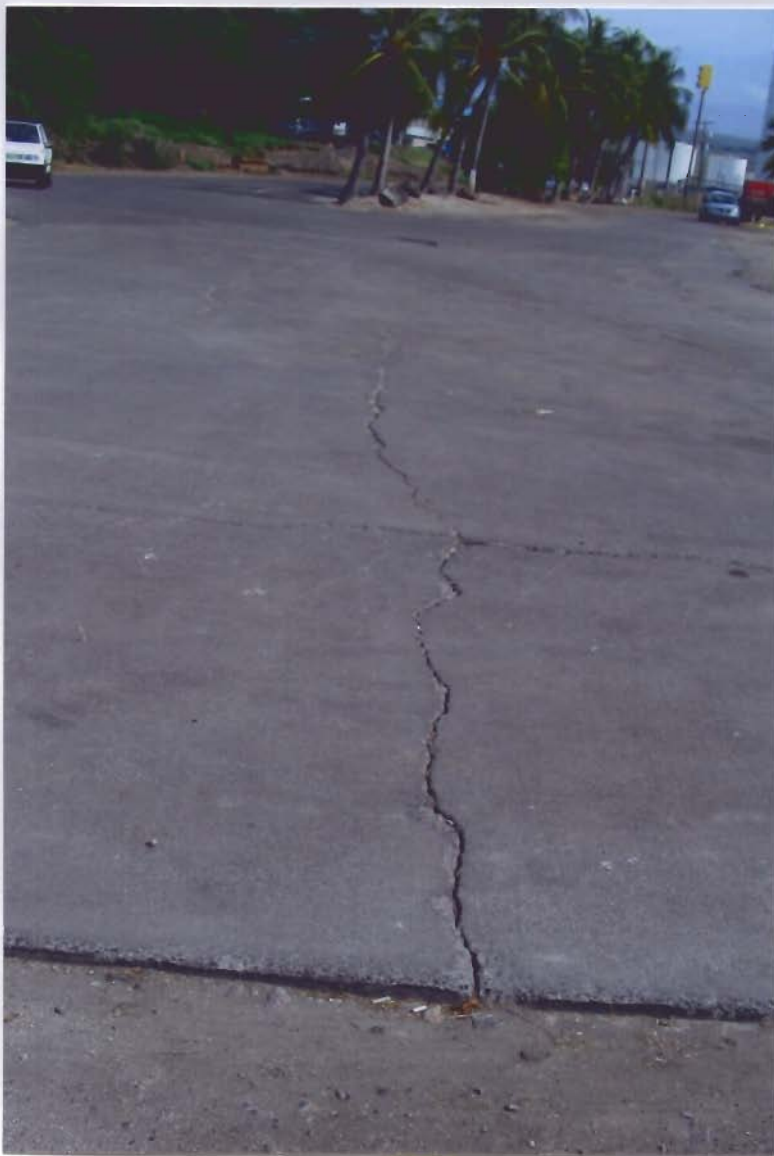
36

Cracks at Boat Ramp Concrete Pavement Slab
